MARINE BORERS

CIVIL ENGINEERING DIVISION
OFFICE OF ENGINEERING

UNITED STATES COAST GUARD HEADQUARTERS
WASHINGTON, D.C. 20590

FINAL REPORT

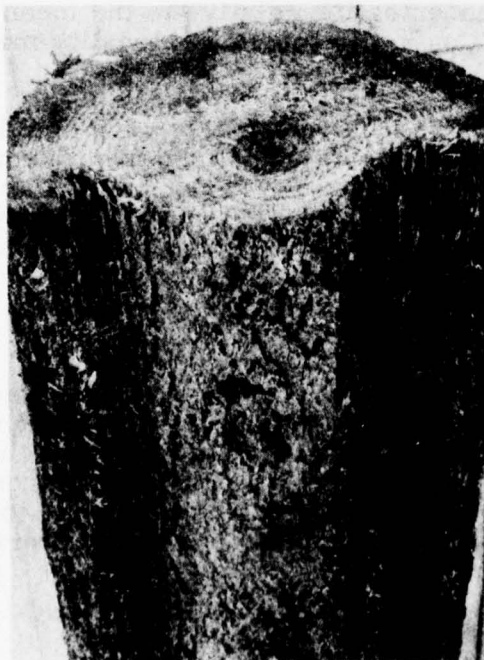
Extensive *Limnoria* damage to piles reducing bearing capacity and restricting usage of facility well under expected service life.

Surface gouging effect of *Limnoria tripunctata* on creosoted pile showing galleries in both the treated and untreated parts of the wood.

Although many techniques have been used to combat marine borers, they cause an estimated \$50 million of damage per year to foreshore marine installations in the United States. Figure 1 shows a facility in Los Angeles Harbor that has sustained extensive damage to creosoted piles in less than (7) years, well under the original contemplated thirty (30) years life of the facility.

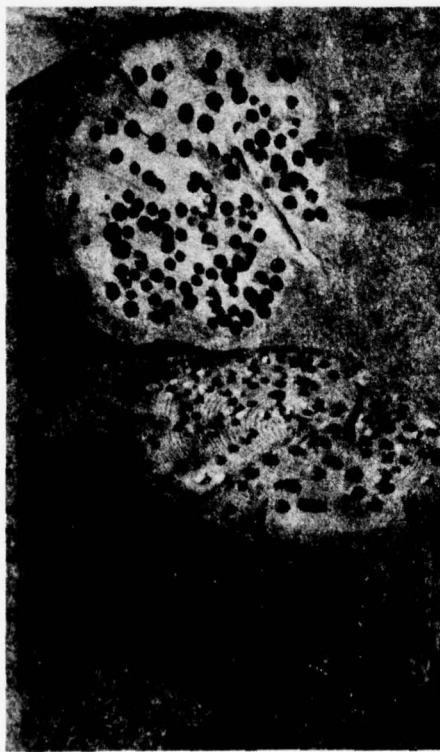
Figure 2

Creosote Treated Pile Section with no visible damage.

Cross-section of Above Pile showing heavy Teredine damage and loss of cross-section.

Longitudinal Section of Same Pile showing the eccentricity of the voids and extensive loss of cross-section.

The most destructive borers and also the most difficult to detect are in the Mollusca Subfamily. Results of their actions are shown in Figure 2. The *Teredo* (Mollusca Subfamily) can destroy an unprotected pile in less than a year, whereas *Limnoria* (Crustacea Subfamily) may take up to 8 years. The area of attack of the marine borer generally extends from the mud line to the high water line, as shown in Figure 6. In the past it was thought that *Limnoria* showed the greatest attack at the mean tide and *Teredo* at the mud line. However, experiments have shown that this is not necessarily the case. In some localities *Teredo* or *Limnoria* may show a particular area of concentration relative to the mean tide line of the pile, yet the point of attack on a pile in another locality may be different.

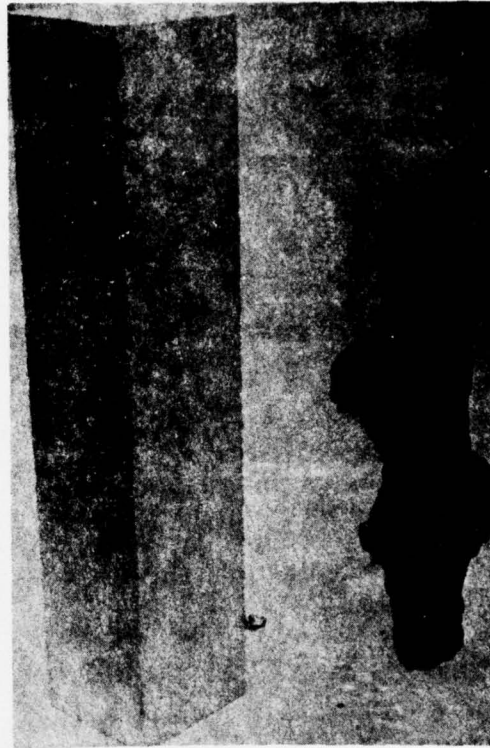
Figure 5

Surface Borer *Limnoria lignorum*
approximately 2-3 mm in length.

Test material before and after
Limnoria attack.

Pile in foreground with classic *Limnoria* 'hourglassing',
two other piles completely destroyed.

2. Crustacean Borers - There are three important Crustacean borers: *Limnoria*, *Sphaeroma* and *Chelura*. *Limnoria*, the most widely distributed of the genera, is illustrated in Figure 5. The *Limnoria* are surface gougers which resemble small lobsters or wood lice about $1/8$ inch (3.2 mm) in length and a width of about $1/3$ the length. The mouth of the *Limnoria* contains a pair of strong, horney-tipped mandibles with which the boring is done. Its body has numerous pairs of legs ending in sharp, hooked claws so that it can move freely and cling to timber. It uses its gill plates for swimming. *Limnoria* destroy timber by producing a lacy network of tunnels at the wood surface, seldom penetrating more than a $1/4$ of an inch (6.4 mm). As these lacy networks of tunnels are eroded away by wave action the animal penetrates deeper into the wood. As many as 400 borers per square inch (645 sq. mm) have been counted on timber under heavy attack. The points of greatest concentration are found near the mud line and mean tide level (See Figure 6) but they may be either distributed uniformly or concentrated anywhere between these limits.

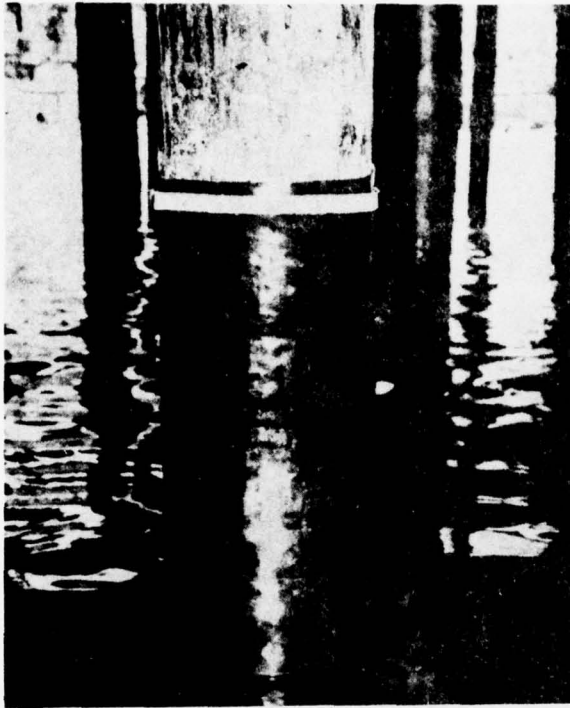
Figure 8

Polyvinyl chloride sheathing wrapped around pile, tightened into position and secured with aluminum bands and nails.

(1) Polyvinyl Chloride (PVC) - Sections of 30 mil (0.76 mm) PVC sheathing are prepared on land and then fitted around the piling in situ and tightened into position, with the encasement usually extending from a point below the mud line up to above the level of the highest anticipated tide. (See Figure 8). An underjacket of 6 mil (0.15 mm) polyethylene is incorporated into the wrap since creosote softens PVC and could result in damage to the wrap. An aluminum alloy band with an intertidal seal is installed at the plus 8 foot (2.4 meters) and minus 2 foot (0.6 meters) points of the tidal zone. The balance of the wrap is secured with aluminum alloy nails. PVC sheathing has demonstrated resistance to impact from floating objects such as log rafts, free floating logs, empty oil drums, crates, and moderate ice action. PVC has been used within ambient temperature range of 0 to 100 F (17.8 to 37.8 C). A Naval Civil Engineering Laboratory study at Port Hueneme, California, has proven the feasibility of using a PVC barrier plus a metal shoe on timber fender piling. The metal shoe is a metal cylinder or similar metal armor installed over the PVC barrier at the tidal zone to prevent mechanical damage to the PVC. The installation of a camel system is recommended for preventing scouring of the ship's hull due to the ship's motion against the metal shoe.

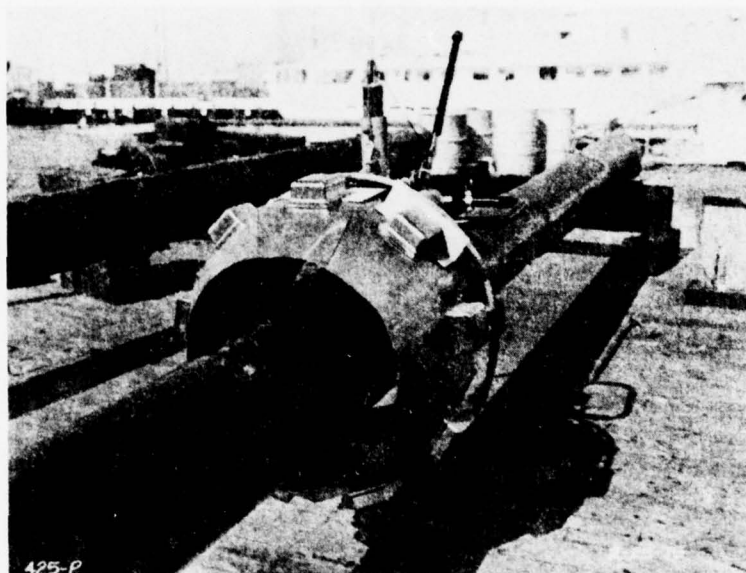
Figure 10

Heat Shrinking Unit shrinking 20 mil (0.5 mm) polyethylene film tightly to the pile. The Port of Los Angeles has handled and driven numerous piles without damaging the film.

(3) Heat Shrink Polyethylene to Timber Piling - Port of Los Angeles Engineering personnel have developed a unit for the application of 20 mil (0.51 mm) polyethylene by heat shrinking directly onto the pile before it is driven. The unit consists of an annular windscreen enclosing a ring of propane fired ceramic burners. (See Figure 10) The polyethylene is applied in 10' 6" sections (3.2 meters). As the unit passes over the polyethylene film, it shrinks circumferentially and tight against the pile and at the same time makes a heat seal at the overlapped portion. The result is a one-piece continuous film of 20 mil (0.51 mm) polyethylene tightly shrunk to the pile. About 5 to 7 feet (1.5 to 2.1 meters) is left uncovered at each end so that the pile may be handled without damaging the film. After driving, all areas of the pile exposed to seawater immersion are protected with polyethylene.

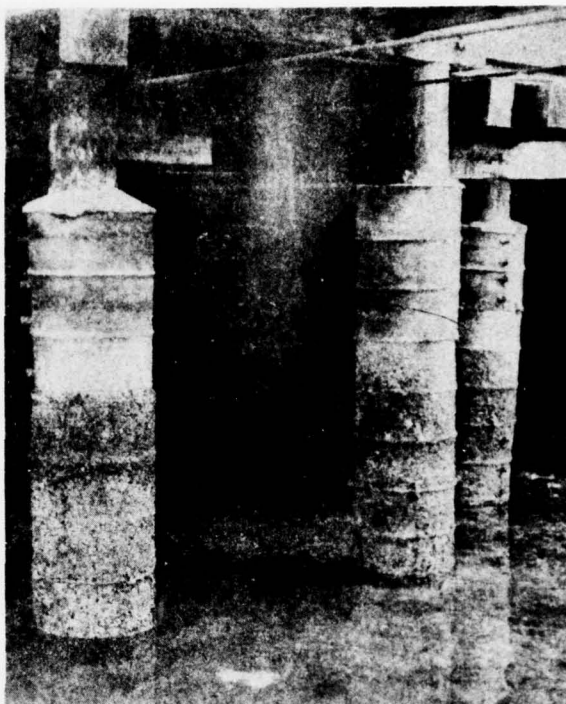
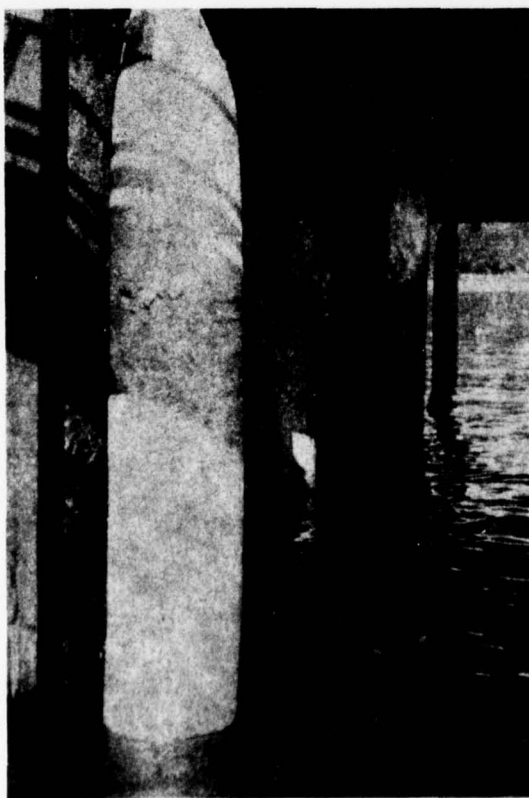
Figure 13

Fabric "sock" or bag installed as a mold around length of damaged pile, reinforcing steel placed and bag pumped full of concrete. Works well on steel H-beam, pipe and pre-stressed concrete pilings as well as on wood.

is installed as a mold around the length of a damaged pile, reinforcing mesh or rods are placed around the pile inside the sock and the sock is pumped full of concrete. (See Figure 13). This process has been used successfully even on piling which are subjected to considerable lateral bending.
